## Unexpected popping in thin asphalt surfaces resolved

Environmental Fact Sheet No. 3

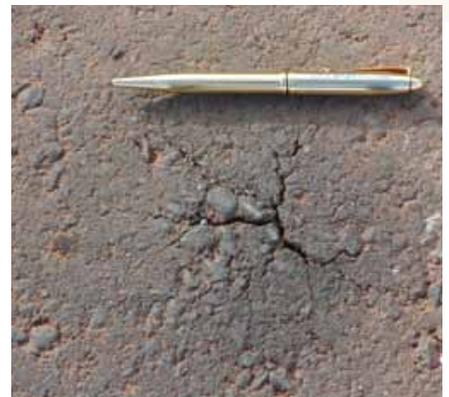
When an asphalt pavement started to have small areas where the surface was being pushed up, like the surface was “popping” (refer Figure 1). An investigation into the cause of the problem was undertaken.

It was determined that the “popping” was indeed caused by corrosion, in this case it was aluminium alloy. This was further traced back to the inclusion of foundry material, which contained the aluminium alloy. The alloy reacted with water and then corroded, increasing in size and pushing the pavement surface up.

Figure 1 – popping in pavement surface

To prevent this from happening again, the recommendation was not to use the foundry material in the material used for the construction of pavements when recycled materials were included.

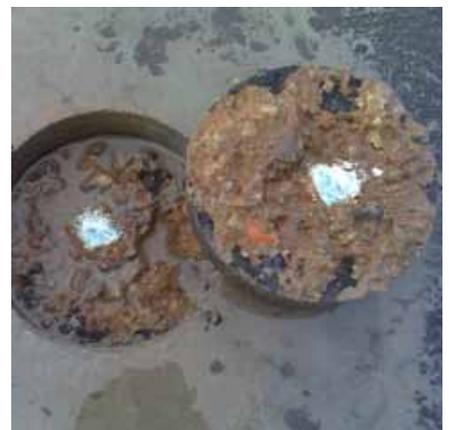
Initially the spots where the deformities were occurring were examined, and a white powder was discovered (refer Figure 2).

This looked like something had corroded, and subsequently an independent consultant was engaged to further investigate the cause of the “popping”.

Figure 2 – white powder
